## Partial Sample Inspection Report

**Property Address:**  
123 Sample Street,  
San Diego, CA 9xxx

**All State Home Inspections, Inc.**

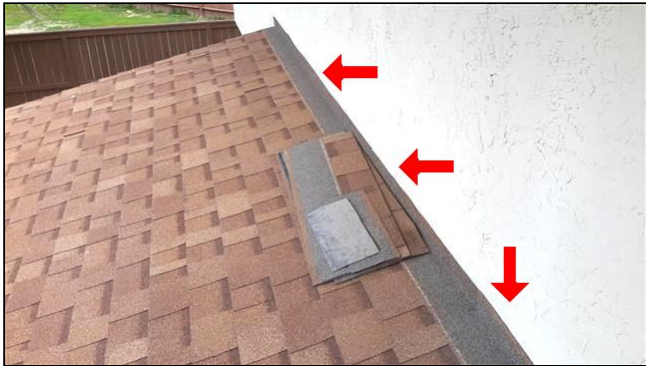
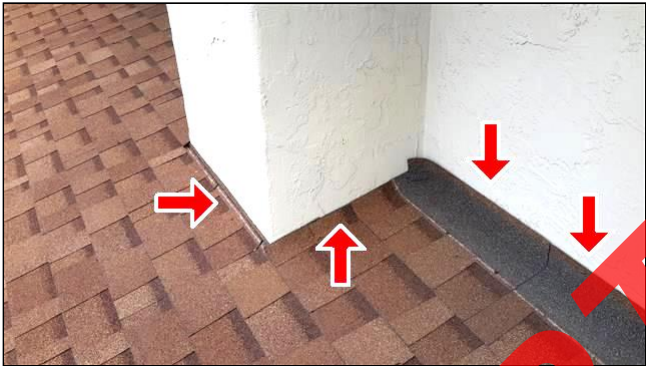
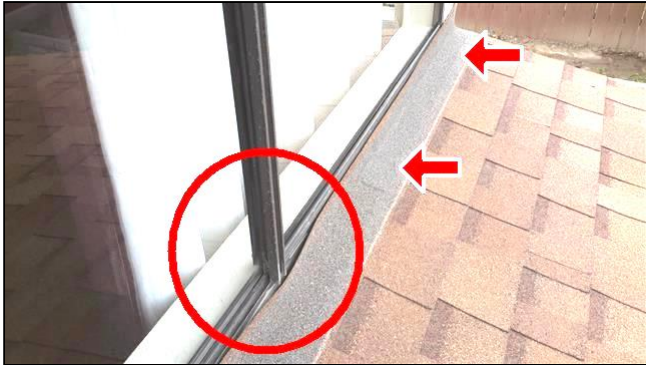
1. 1. There is no evidence of proper flashing at the roof top and the side of the house meet for the rear yard awning. Currently, there is 3-Tab shingles installed in place which is not adequate. Additionally, the shingles have many gaps that allow tunneling directly behind this area that should be protected. This may cause unwanted damage and costs for repair.
  - We recommend that a licensed roofing contractor evaluate and repair/replace as needed.

Item 1 - Item- (Picture 1) No evidence of proper flashing

Item 1 - Item- (Picture 2) No evidence of proper flashing

Item 1 - Item- (Picture 3) No evidence of proper flashing

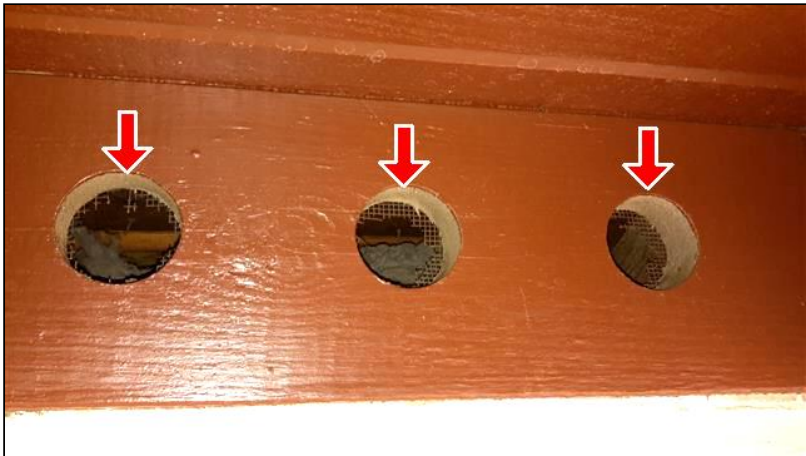
The soffit vent holes screens are broken/worn and may allow unwanted animals and pests into your attic which may cause unwanted damage and costs for repair.

Item 2 - Item- (Picture 1) Screens are broken/worn

We recommend that a licensed contractor evaluate and replace as needed.

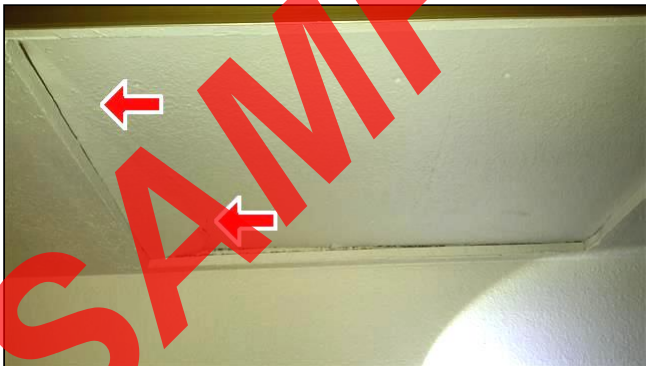
The attic access panel located in the Master Bedroom closet is cracked/damaged. This may allow unwanted access to insects and loss of energy savings.

Item 4 - Item- (Picture 1) Attic access panel is cracked/damaged

We recommend that a licensed contractor evaluate and replace as needed.

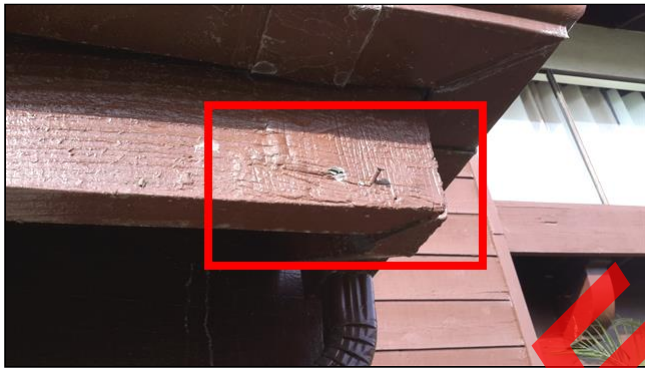
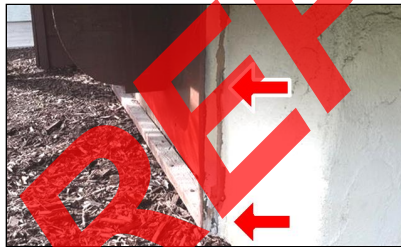
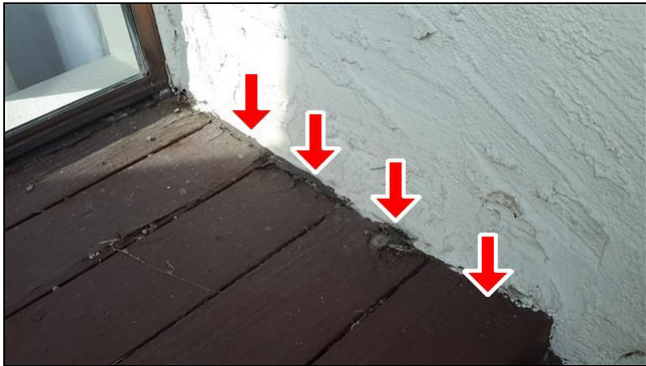
5. 1. **Item- (Pictures 1 - 3).** - There are many areas where the the wood trim and the wood ledges show indications of dry rot damage and or pest damage. This is caused from moisture intrusion, lack of paint or sealed wood areas, and/or WDO's to include termites. The areas should be sealed to prevent moisture intrusion and/or Wood Destroying Organisms which include termite and other wood destroying insects. This is known as **WDO**. See [Comment Key or Definitions -"WDO" for definition.](#)

Item 5 - Item- (Picture 1) Trim dry rotting

Item 5 - Item- (Picture 2) Wood rot & wood exposed

Item 5 - Item- (Picture 3) Wood ledge dry rotting

- **We recommend that a licensed pest contractor and general contractor evaluate and repair/remediate as needed.**
2. **Item- (Pictures 4 - 9)** - The exterior stucco has holes that are not sealed and many small cracks. These holes and cracks are not structural damage but cosmetic which is cause by normal earth movement and the property settlement. The areas should be sealed to prevent moisture intrusion and/or Wood Destroying Organisms which include termite and other wood destroying insects. This is known as **WDO**. See [Comment Key or Definitions -"WDO" for definition.](#)

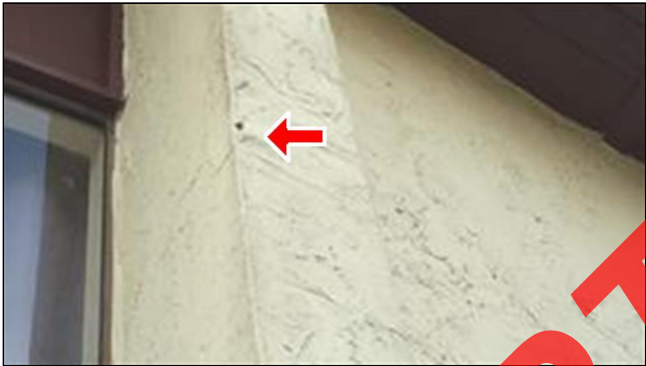
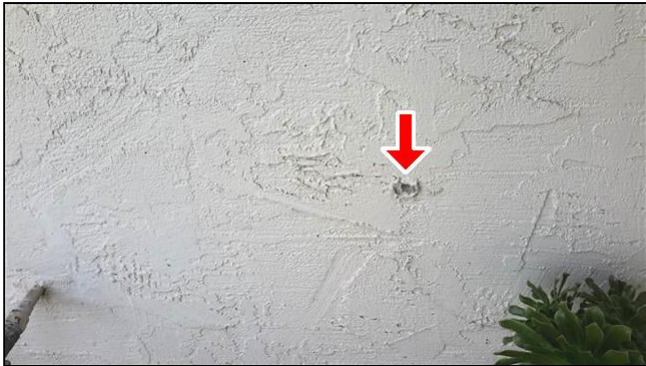
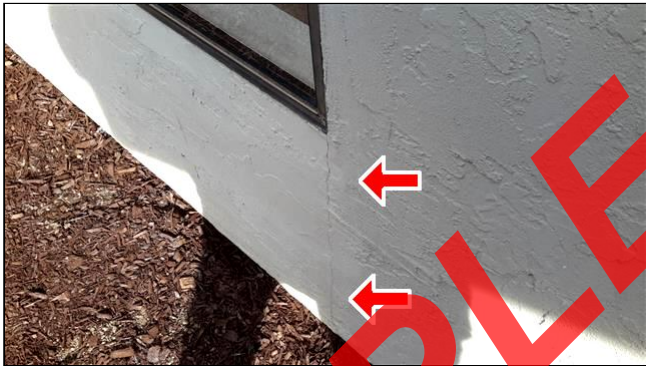
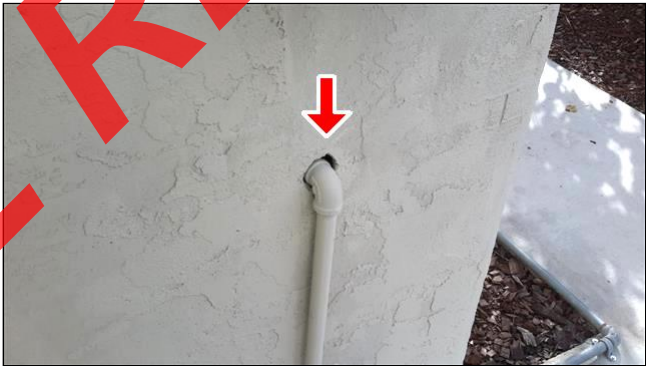
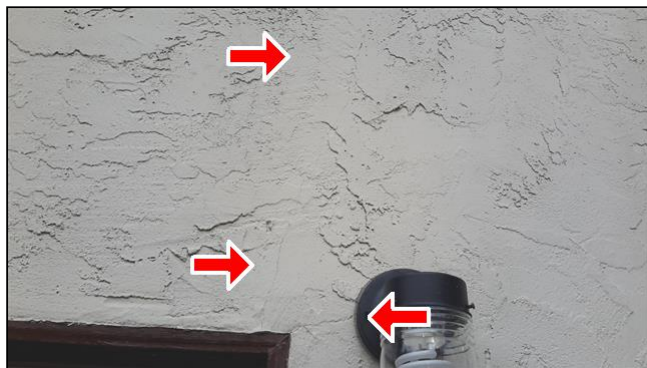
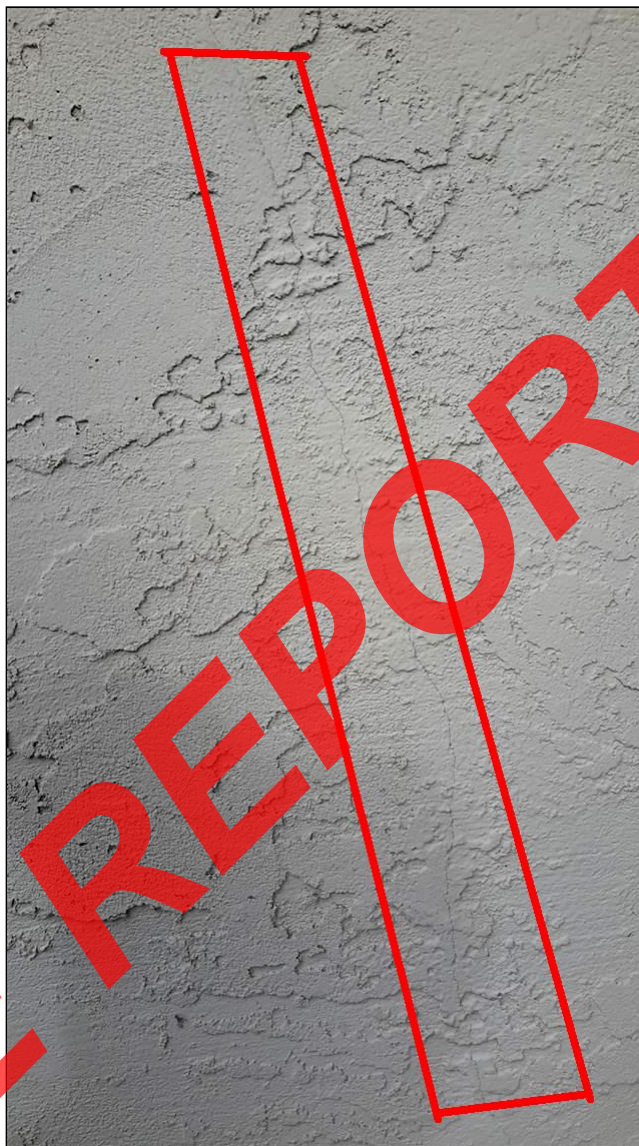
Item 5 - Item- (Picture 4) Small hole in the stucco

Item 5 - Item- (Picture 5) Small hole in the stucco

Item 5 - Item- (Picture 6) Small exterior crack

Item 5 - Item- (Picture 7) Pipe and stucco not sealed

Item 5 - Item- (Picture 8) Small crack in the stucco

Item 5 - Item- (Picture 9) Small crack in stucco wall

- **We recommend that a licensed pest contractor and general contractor evaluate and repair/remediate as needed.**

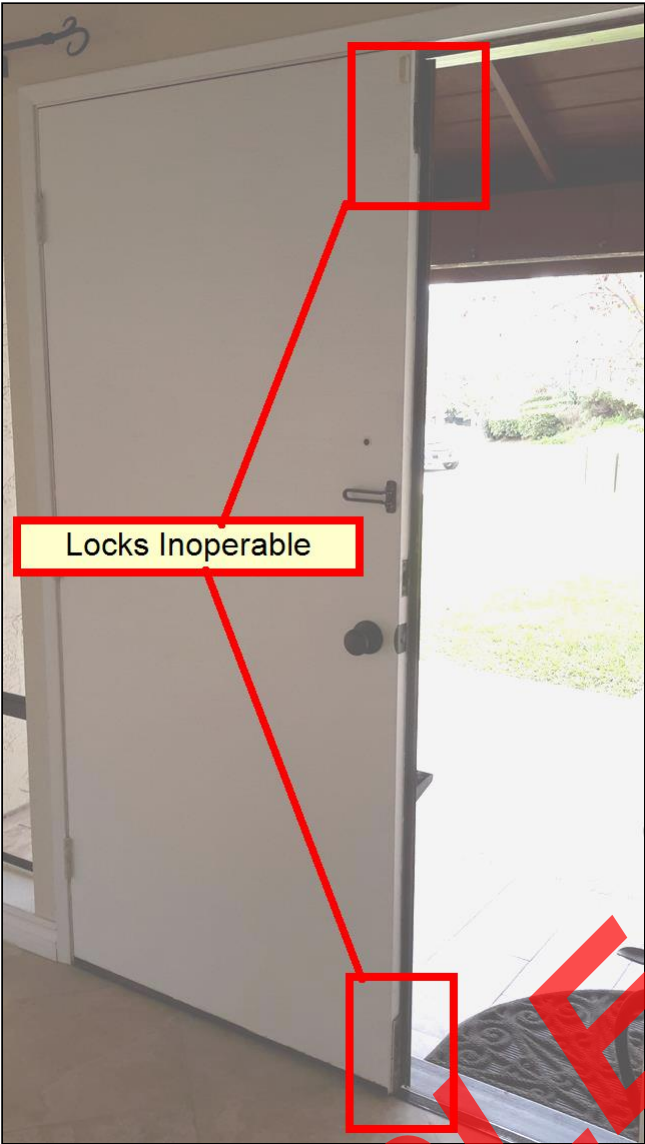
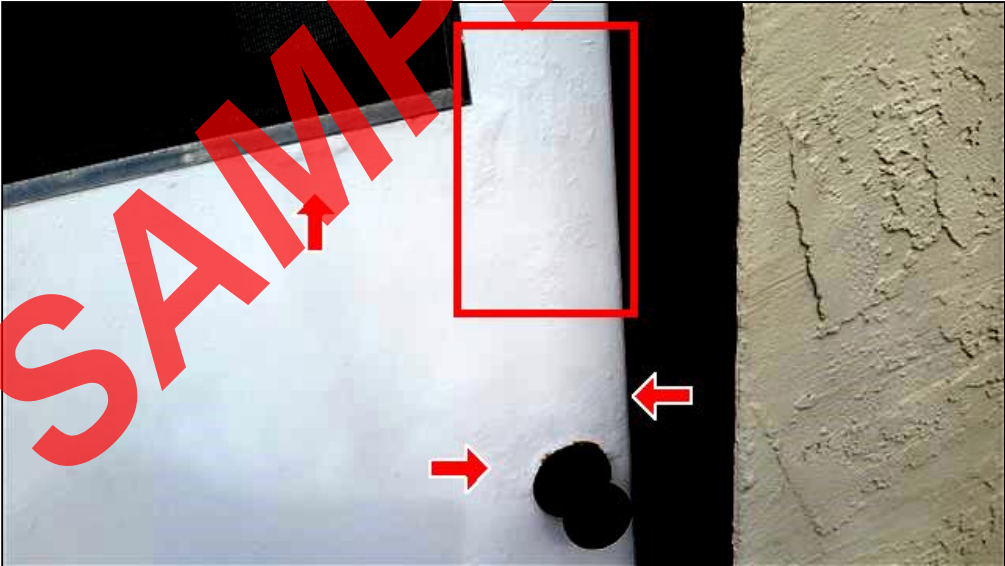
6.
  1. Item- (Picture 1) - The front right door does not lock. This door has an upper and a lower lock to support locking the left door. The left door lock, due to the broken locks, prevents both front doors from locking and security. Due to the right door unable to lock, even though the left door is locked, pushing both doors open at the same time opens the doors regardless if the left door being locked. **This is a SECURITY HAZARD.**
  2. Item- (Picture 2) - The laundry room door that leads to the exterior side yard has moisture damage. This door should be kept sealed/painted to prevent unwanted damage and costs for repair.

Item 6 - Item- (Picture 1) Door locks broken

Item 6 - Item- (Picture 2) Moisture damage to the exterior of the door

- We recommend that a licensed contractor evaluate and repair/replace as needed.

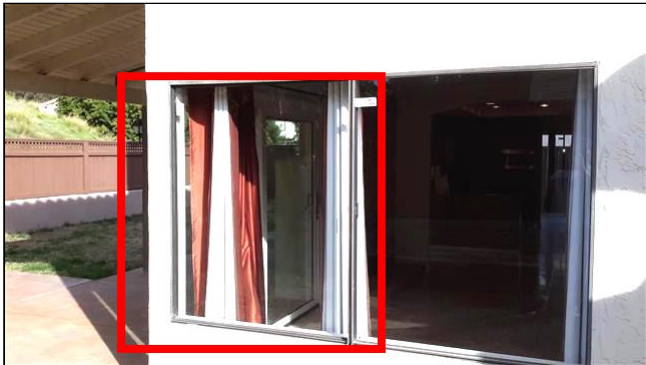
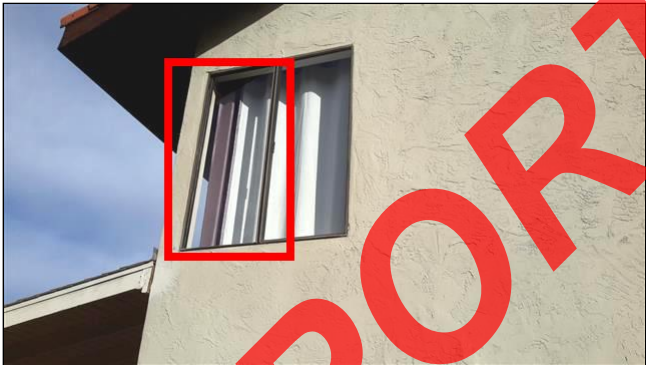
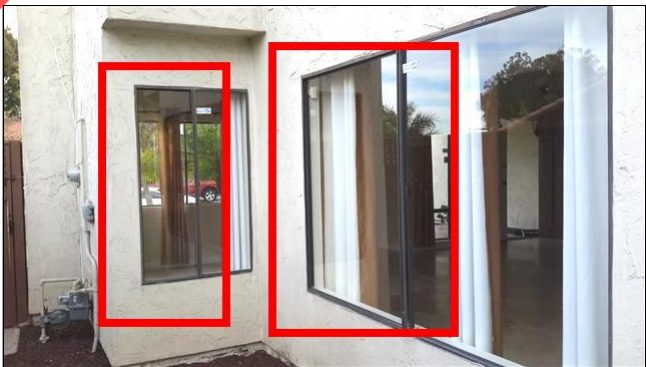
All of the exterior windows and sliding glass doors do not have the screens installed. Screens are important as they allow the windows/doors to be opened and prevents animals, debris, and insects to enter the home which may cause unwanted damage and costs for repairs. All Window and door manufactures designed their products with screens/screen doors. and should be installed with no holes and/or tears/damage to the screens and their framing.
- We recommend that a licensed window contractor evaluate and install/repair/replace as needed.

Item 7 - Item- (Picture 1) No window screens installed

Item 7 - Item- (Picture 2) No window screens installed

Item 7 - Item- (Picture 10) No window screens installed

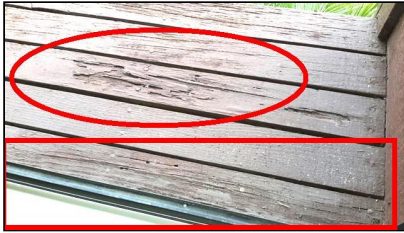
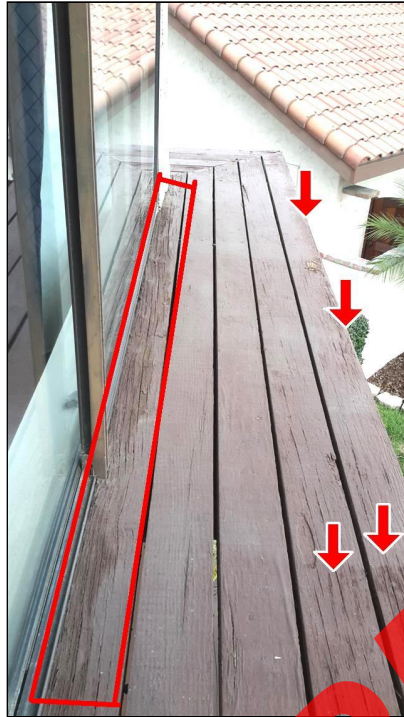
8. 1. There is indications of wood rot WDO's present on the exterior window wood ledge.
- **We recommend that a licensed pest contractor evaluate and remediate as needed.**

Item 8 - Item- (Picture 1) Wood Rot Damage

Item 8 - Item- (Picture 2) Wood Rot Damage

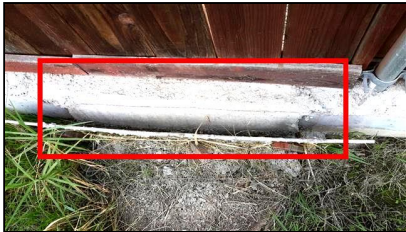
9. 1. Item- (Picture 1) - **NOTE:** Repair to rear block wall below wooden fence. In serviceable condition.
2. Item- (Pictures 2 - 4) There are small cracks on the driveway concrete. These cracks are cause from normal settlement and/or earth movement. The cracks should be sealed to prevent moisture intrusion which may, cause unwanted soil movement under the cement slab with unwanted damage and costs for repair.

Item 9 - Item- (Picture 1)  
Concrete block wall repair

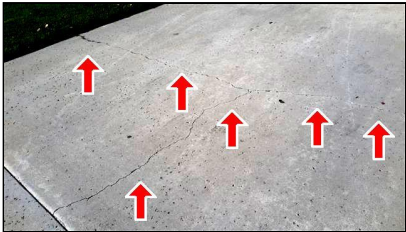
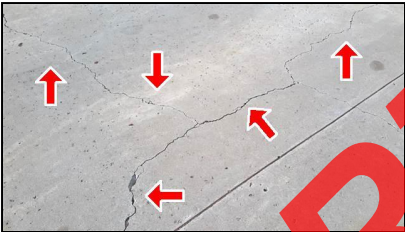
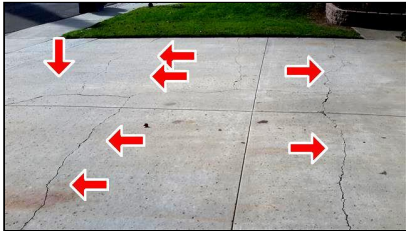
Item 9 - Item- (Picture 2) Small  
cracks

Item 9 - Item- (Picture 3) Small  
cracks

Item 9 - Item- (Picture 4) Small  
cracks

- **We recommend that a licensed contractor evaluate and seal as needed.**
3. Item- (Pictures 5, 6) The metal fencing is loose and missing hardware to secure the system to the block wall. This may cause unwanted damage and costs for repair if not secured properly.

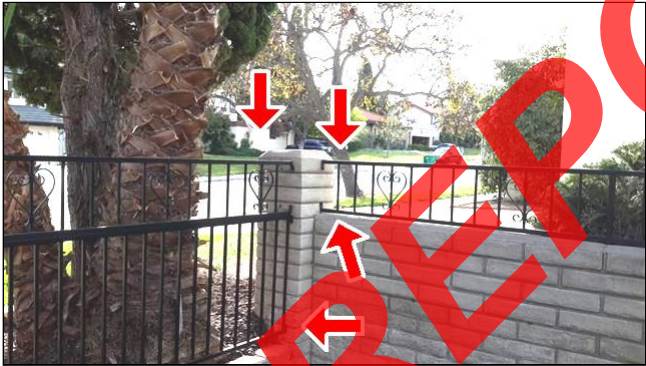
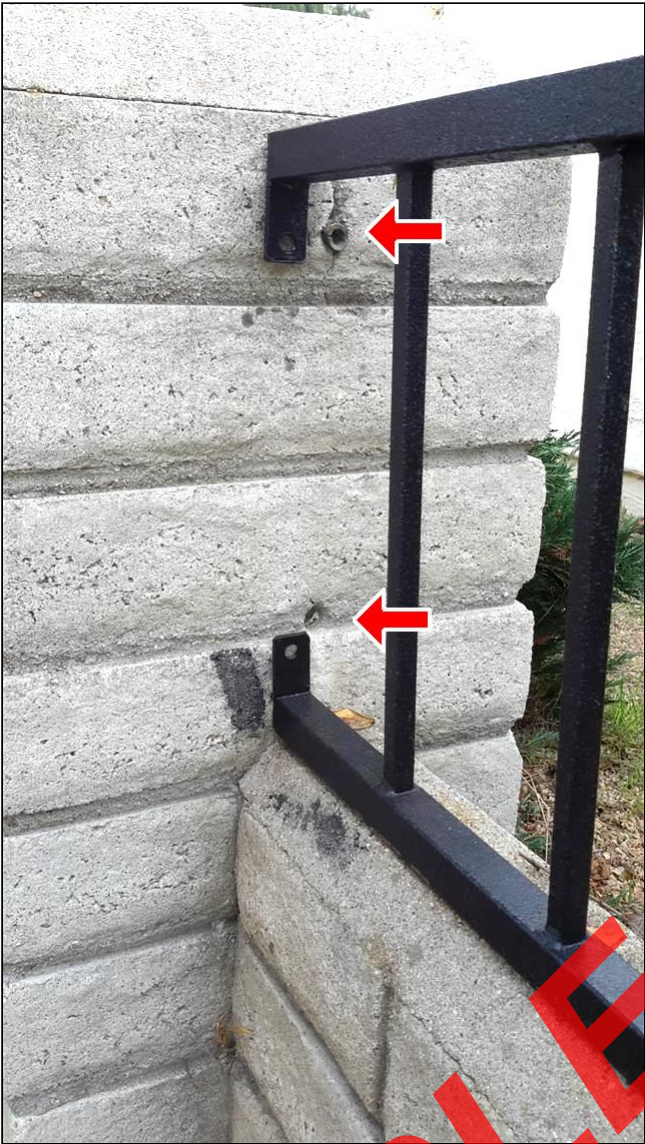
Item 9 - Item- (Picture 5) Loose metal  
fencing

Item 9 - Item- (Picture 6) Missing bolts to railing

- **We recommend that a licensed contractor evaluate and repair/secure as needed.**
4. Item- (Picture 7) There are many areas where the concrete top is cracked. This may allow moisture intrusion and unwanted damage and costs for repair.

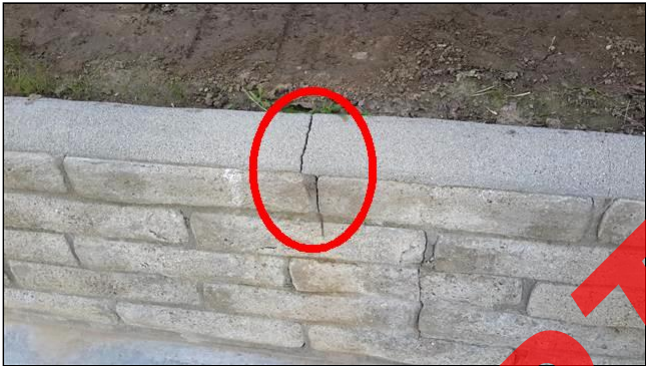
Item 9 - Item- (Picture 7) Small crack

- **We recommend that a licensed contractor evaluate and seal/repair as needed.**
5. Item- (Picture 8) Some of the vegetation is growing close to the wooden fencing. Vegetation need moisture and will retain moisture. It is important to maintained the vegetation. This may cause unwanted damage and costs for repair.

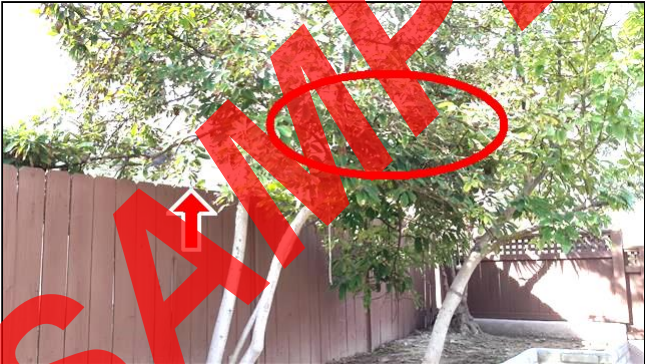
Item 9 - Item- (Picture 8) Vegetation growing toward the wooden fence

- **We recommend that a licensed landscaper/arborist evaluate and maintain as needed.**
9. Item- (Picture 9) There are indications of rodent tunneling such as goffer holes. The holes have been partially filled. These rodents tunnel in the ground and may tunnel under the foundation which may cause unwanted damage and costs for repair.

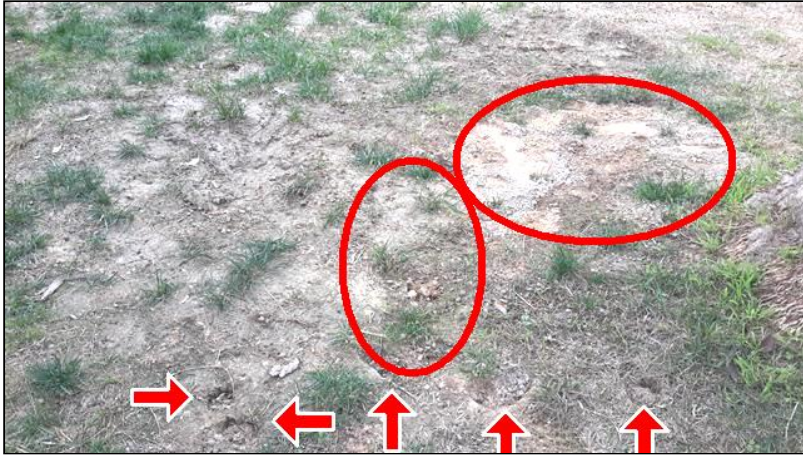
Item 9 - Item- (Picture 9) Indication of goffer holes

- **We recommend that a licensed pest contractor evaluate and remediate as needed.**

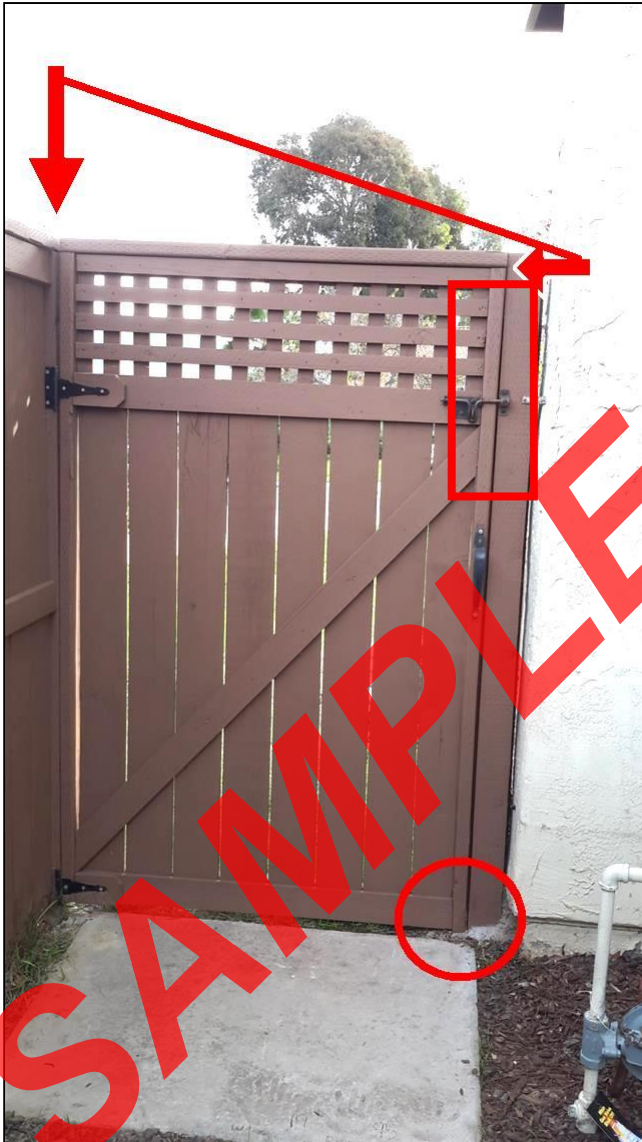
10. Item- (Picture 10) The gate rubs on the concrete and the locking post. This is caused from the gates weight causing the fence and the post to lean.

Item 9 - Item- (Picture 10) Gate heavy causing gate to rub

- We recommend that a licensed contractor evaluate and repair as needed.

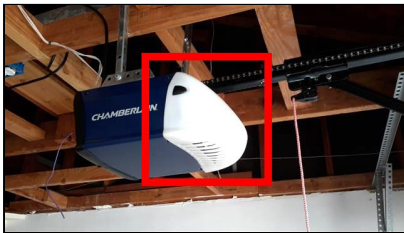
12.
  1. Both of the garage door were test for the reverse function. Although it reversed, it took extra pressure to retract.
  2. The single door opener light did not turn on. This may be a simple light bulb replacement or a defective appliance.
    - **We recommend that a licensed contractor evaluate and adjusts/replace as needed.**

Item 12 - Item- (Picture 1) Light to single door does not work

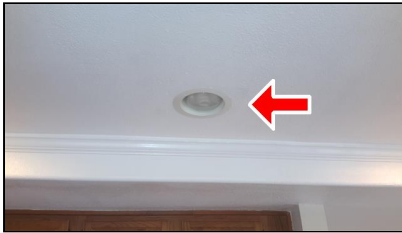
14.
  1. There is one ceiling light that does not work. This may be a simple light bulb replacement or the fixture is defective.
    - **We recommend that a licensed contractor evaluate and repair/replace as needed.**

Item 14 - Item- (Picture 1) light does not work

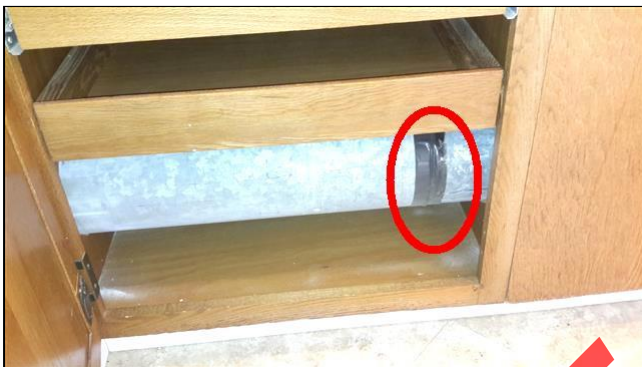
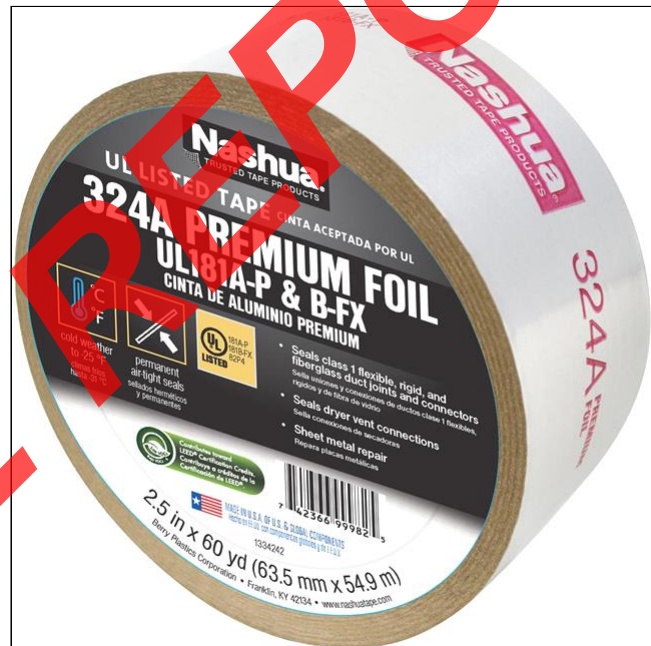
15.
  1. The range exhaust vent tube has a flammable tape at the joint of the tube. The correct joint tape is metallic and non flammable. **This is considered a FIRE SAFETY HAZARD which may cause personal injury and/or property damage.**
  2. **We recommend that a licensed contractor evaluate and replace/install/repair as needed.**

Item 15 - Item- (Picture 1) Incorrect ducting tape

Item 15 - Item- (Picture 2) Foil Tape Example

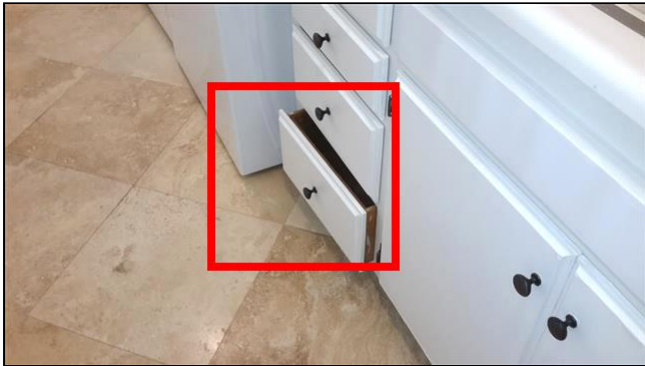
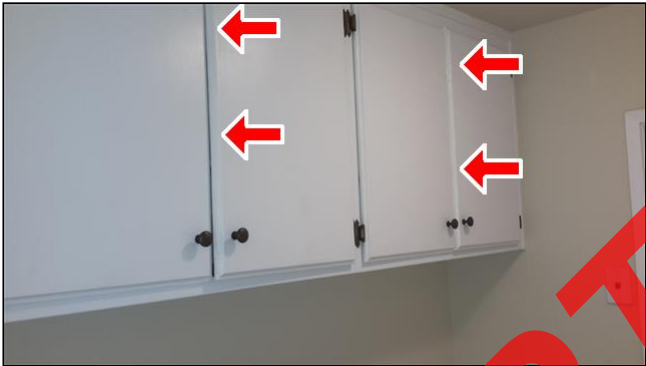
17.
  1. The bottom drawer is missing the plastic guide that glides along the rail. This may cause unwanted damage and costs for repair.
  2. The upper cabinet doors bind when closing. This may cause unwanted damage and costs for repair.
    - **We recommend that a licensed contractor evaluate and repair as needed.**

Item 17 - Item- (Picture 1) drawer missing guides

Item 17 - Item- (Picture 2) Doors bind when closing

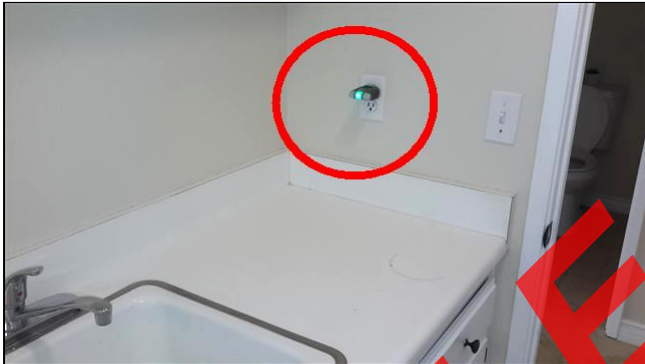
18. 1. The receptacle adjacent to the laundry sink is not Ground Fault Circuit interrupter (GFCI) protected. The home indications of up grading of the electrical. All receptacles within 6 feet of a water fixture must be GFFCI protected. **This is an ELECTRICAL SAFETY HAZARD which may cause persona injury (including death) and/or property damage.**
- We recommend that a licensed electrical contractor evaluate and install as needed.

Item 18 - Item- (Picture 1) Receptacle is not GFCI protected

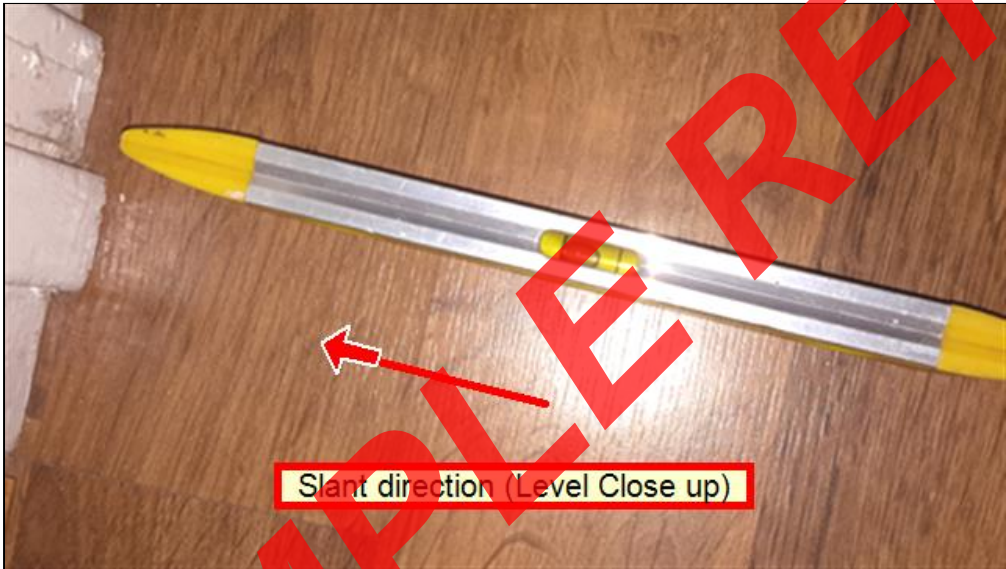
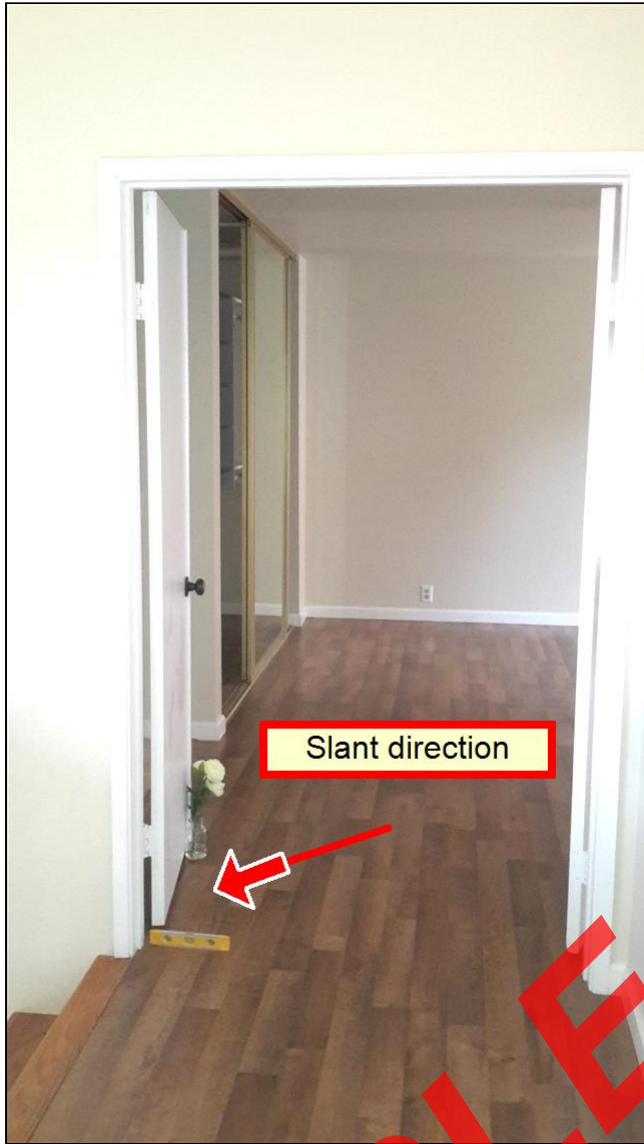
22. 1. The entryway is slanted to the left when facing the door from the hallway. The slant is small and causes the door to swing open unless it is in a locked closed position. This is a minor slant and which is caused from the home settling over time. The structures integrity is not affected.
- We recommend that a licensed contractor evaluate and repair as needed.

Item 22 - Item- (Picture 1) Floor slants

Item 22 - Item- (Picture 2) Floor slants

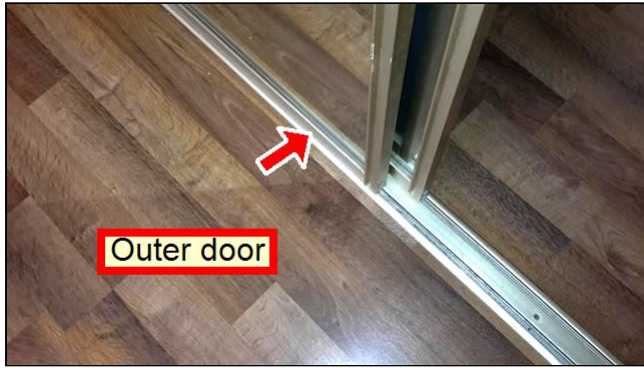
23. 1. The outside door does not open as intended and jumps when sliding. This is caused from worn/broken caster wheels under/behind the door. This may cause unwanted damage and costs for repair if not corrected.
- **We recommend that a licensed contractor evaluate and replace/adjust as needed.**

Item 23 - Item- (Picture 1) Door caster wheels worn/ broken

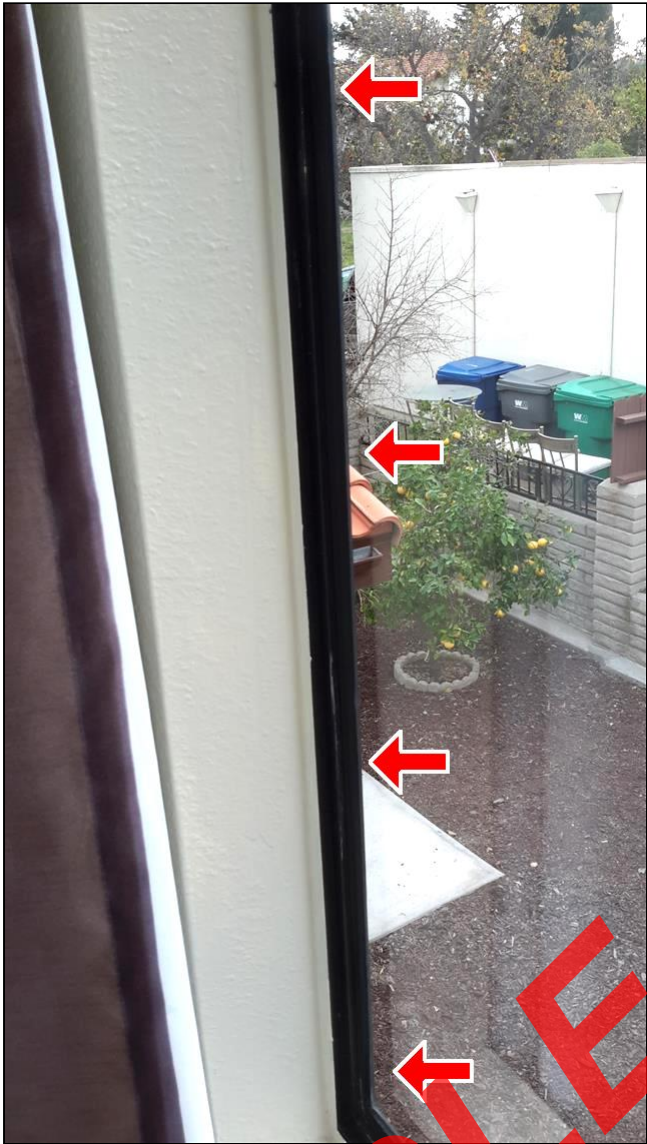
- 24.
1. The stationary glass frame is loose inside the outer entire frame. This glass may rattle with vibrations and/or high winds and which may break the glass, This may cause unwanted loss of energy, damage and costs for repair.
  2. See Section 2.2 Exterior Windows for more information.
    - **We recommend that a licensed window contractor evaluate and repair/replace as needed.**

Item 24 - Item- (Picture 1) Glass frame is loose

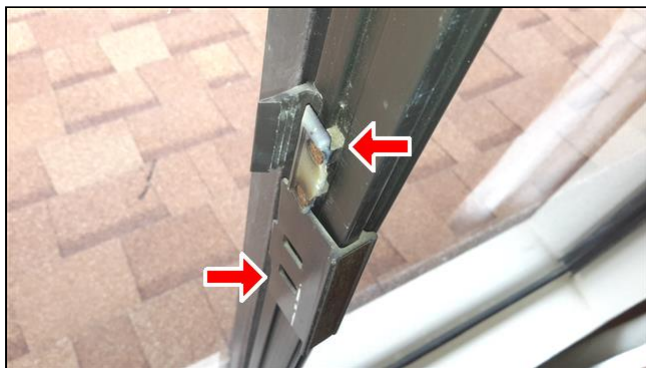
25. 1. The window lock is broken. This prevents the window from locking per the manufactures design and intentions.  
2. See Section 2.2 Exterior Windows for more information.  
• We recommend that a licensed window contractor evaluate and repair/replace as needed.

Item 25 - Item- (Picture 1) Window lock broken

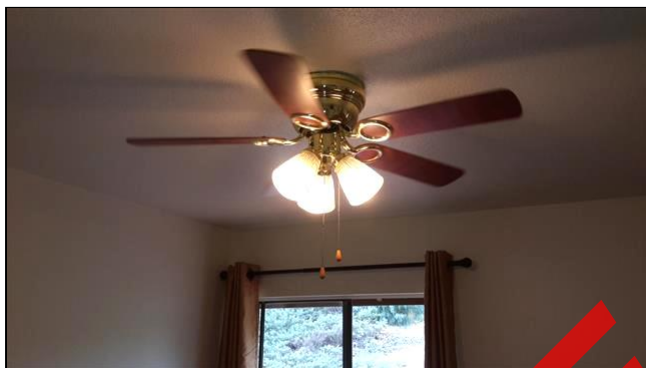
26. 1. The ceiling fan spins slow when in Hi, Medium, and Low settings. This is an indication the fan motor is failing.
- **We recommend that a licensed contractor evaluate and repair/replace as needed.**

Item 26 - Item- (Picture 1) Fan spins slow at all settings

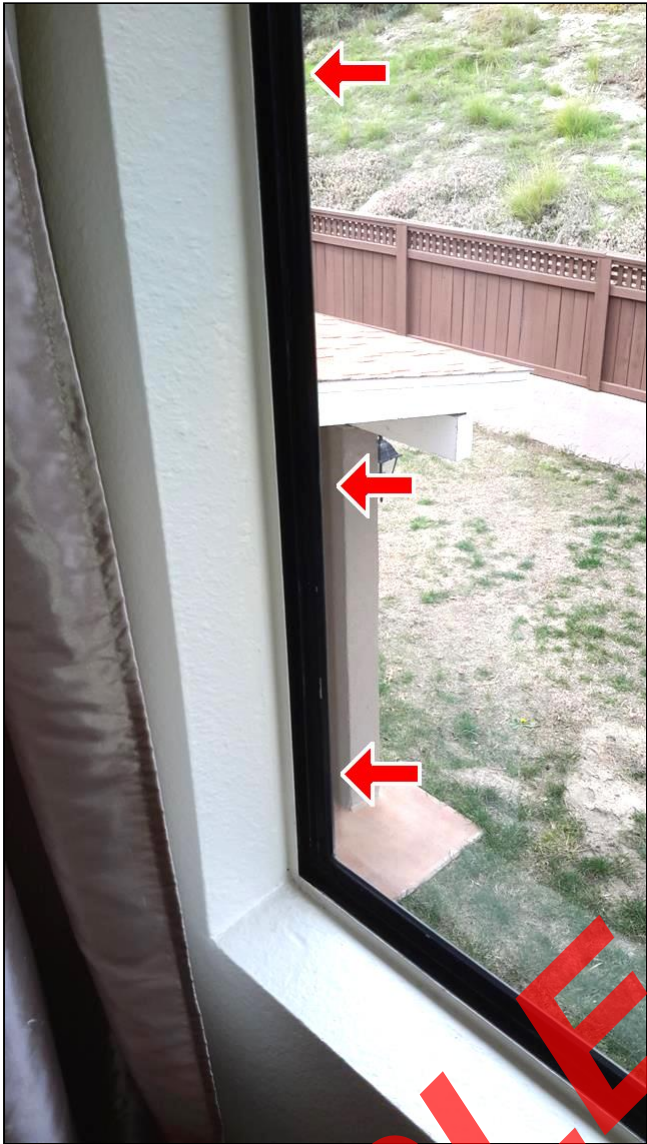
27. 1. The stationary glass frame is loose inside the outer entire frame. This glass may rattle with vibrations and/or high winds and which may break the glass, This may cause unwanted lose of energy, damage and costs for repair.
2. See Section 2.2 Exterior Windows for more information.
- **We recommend that a licensed window contractor evaluate and repair/replace as needed.**

Item 27 - Item- (Picture 1) Window shakes within the frame (Loose)

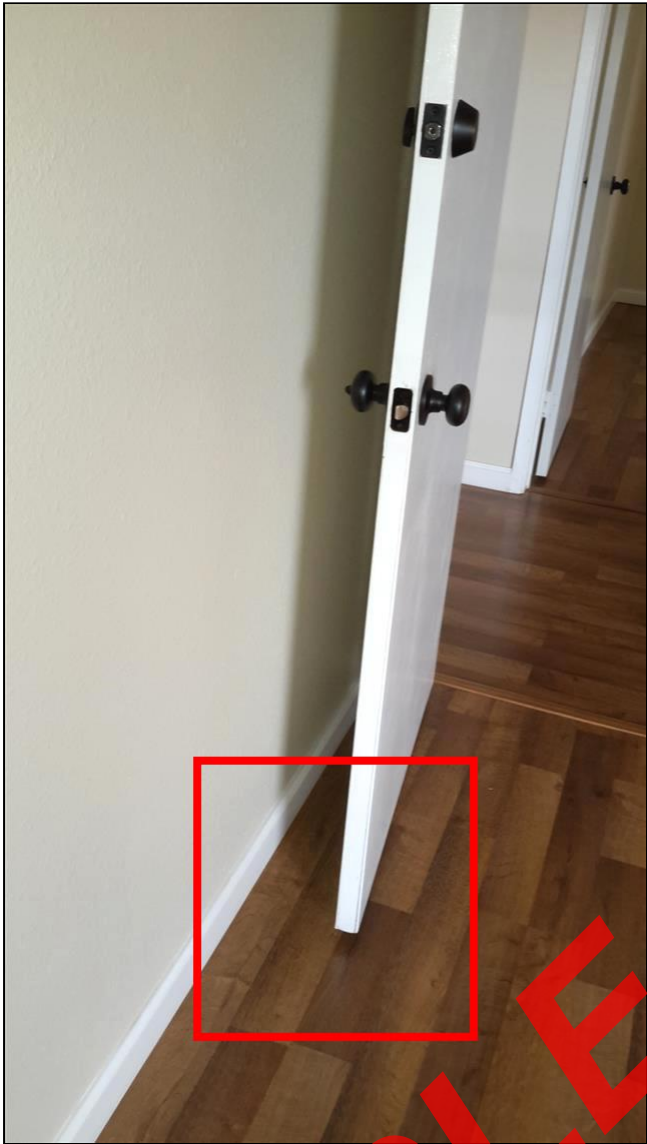
28. 1. The entry door has no door stop. Door stops are important as they prevent the door from over extending which may allow the door knob to damage the wall which, may be unwanted damage and costs for repairs.
- We recommend that a licensed contractor evaluate and install as needed.

Item 28 - Item- (Picture 1) Missing door stop

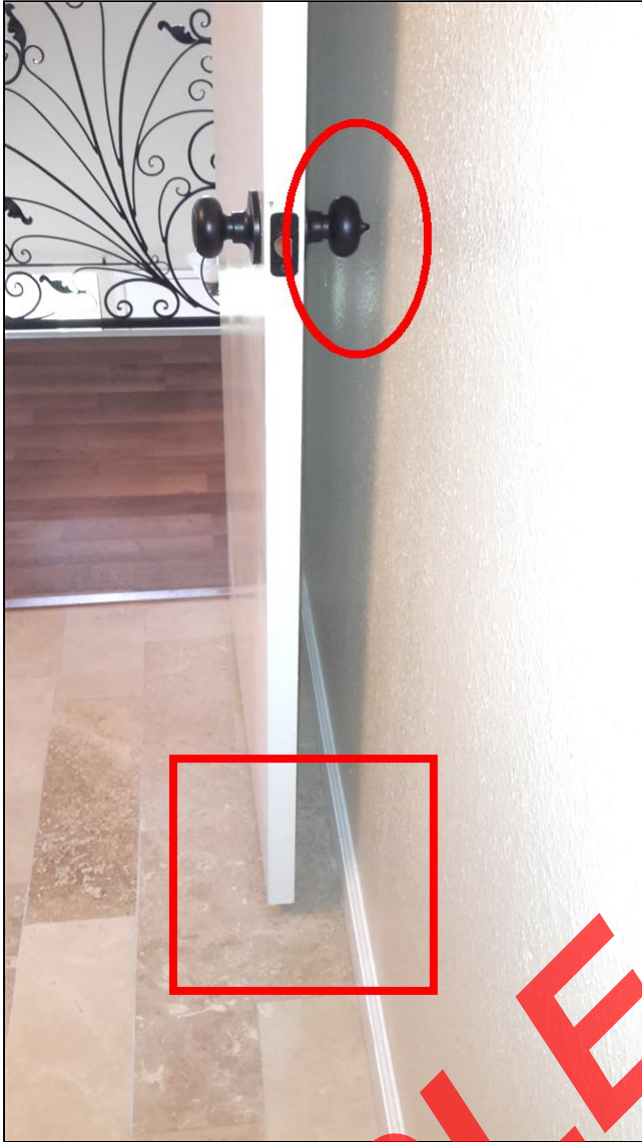
The entry door has no door stop. Door stops are important as they prevent the door from over extending which may allow the door knob to damage the wall which, may be unwanted damage and costs for repairs.
  - We recommend that a licensed contractor evaluate and install as needed.

Item 30 - Item- (Picture 1) Missing door stop

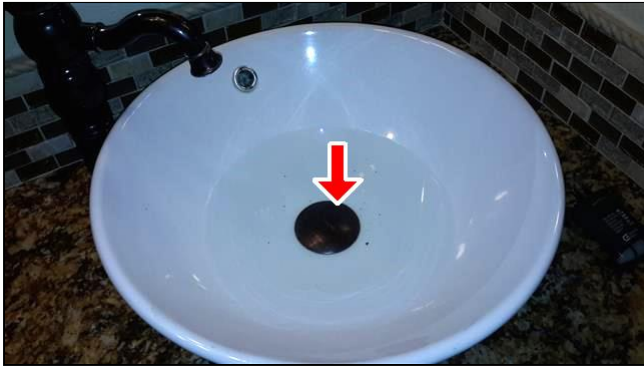
32. 1. The sink stopper on the right sink is stuck in the closed position. The stopper does not release to drain the sink basin.
- We recommend that a licensed plumbing contractor evaluate and repair/replace as needed.

Item 32 - Item- (Picture 1) Sink drain stopper is stuck closed

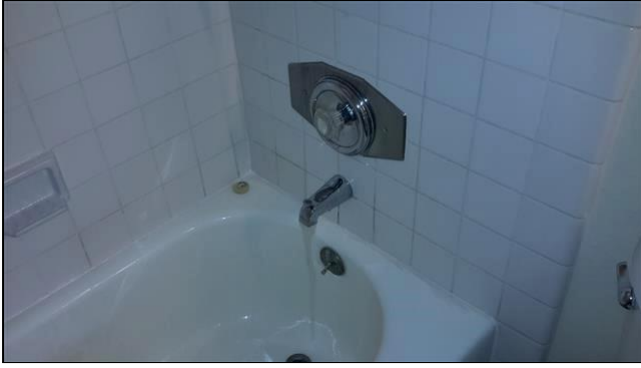
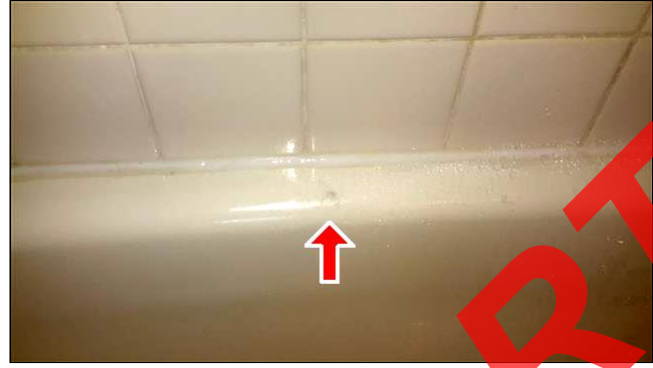
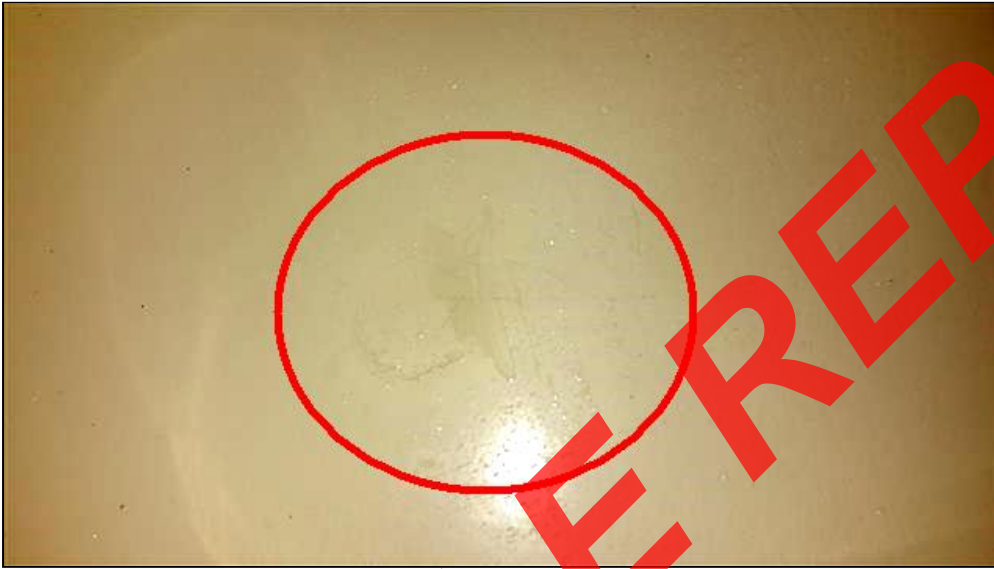
33. 1. Item- (Picture 1) The water pressure is very low when other faucets or toilet is flushed. This is not a normal instance.
- We recommend that a licensed plumber evaluate and repair/replace as needed.
2. Item- (Pictures 2 & 3) There is a small chip on the edge of the tub. Additionally, there are many small cracks in the tubs finish. This condition may cause premature wear/rust and unwanted damage and costs for repair.
- We recommend that a licensed contractor evaluate and repair/replace as needed.

Item 33 - Item- (Picture 1) Low water pressure

Item 33 - Item- (Picture 2) Small chip in the tub

Item 33 - Item- (Picture 3) Small cracks in the tub finish

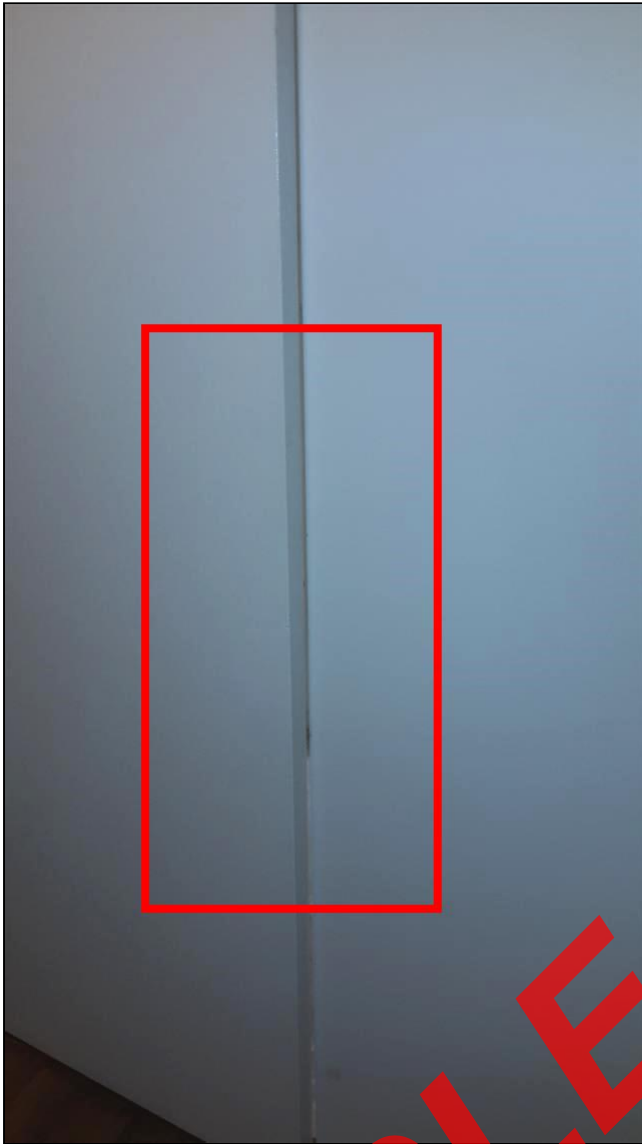
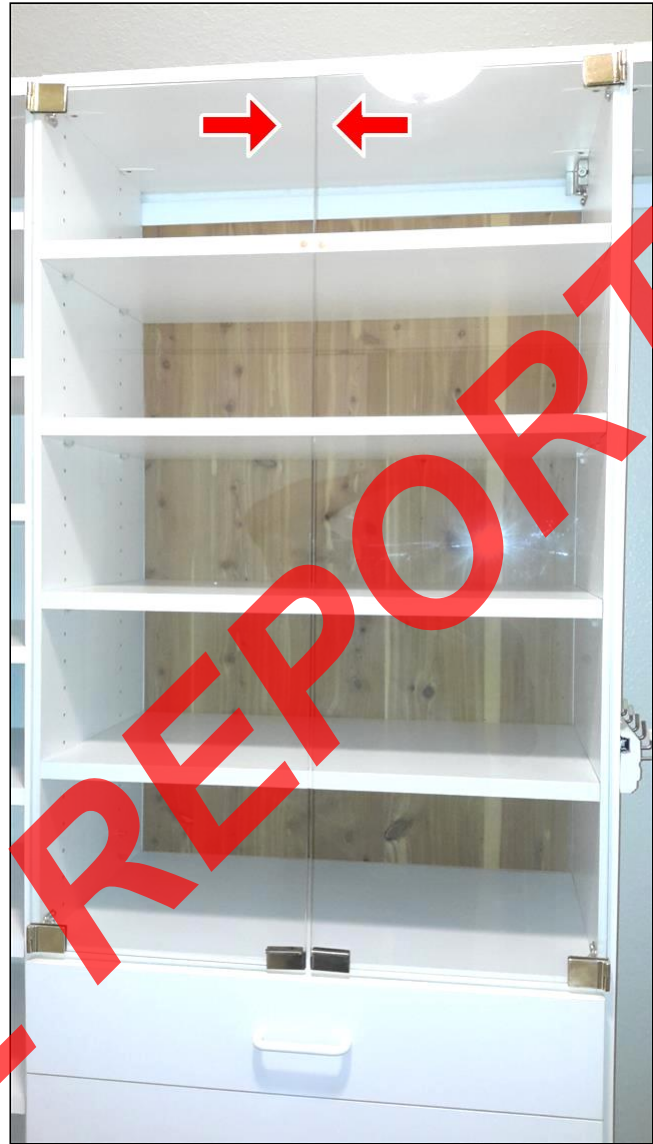
- 34.
1. Item- (Picture 1) The closet door do not have door knobs/handles on the inside. If the doors are closed when you are in the inside of the closet, you will lick yourself inside the closet and have no wa to open the doors.
  2. Item- (Picture 2) The glass doors are offset and bind when closing/opening the doors. This may cause premature unwanted damage and costs for repair.
- We recommend that a licensed contractor evaluate and repair/install/adjust as needed.

Item 34 - Item- (Picture 1) Missing door knob/handles

Item 34 - Item- (Picture 2) Glass doors bind when closing

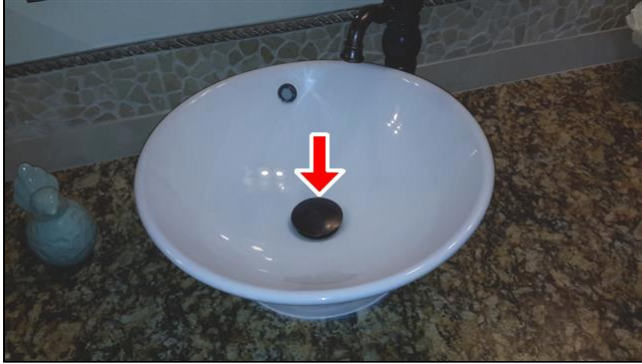
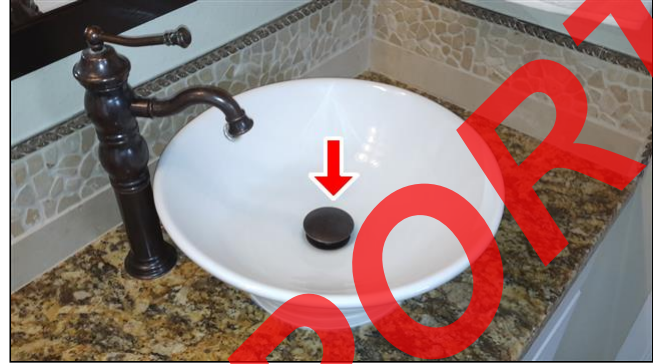
36. 1. Item- (Pictures 1 & 2) Both sink drain stops do not open and close properly. This may prevent the sink basin to be filled or drain properly.
- We recommend that a licensed plumbing contractor evaluate and repair/replace as needed.

Item 36 - Item- (Picture 1) Drain stop is stuck

Item 36 - Item- (Picture 2) Drain stop is stuck
