## Partial Sample Inspection Report

**Property Address:**  
123 Sample Street,  
San Diego, CA 9xxx

**All State Home Inspections, Inc.**

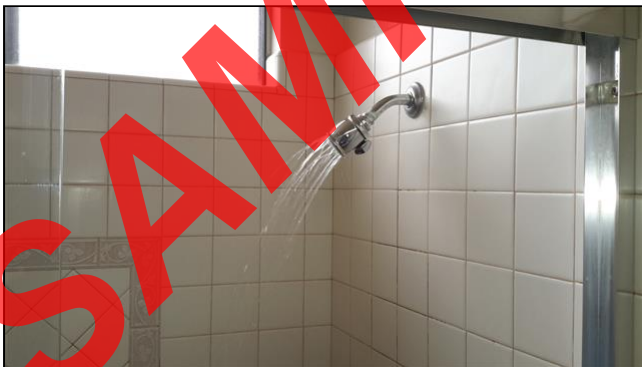
37. 1. Item- (Picture 1) The water pressure is very low when other faucets or toilet is flushed. This is not a normal instance.
- We recommend that a licensed plumber evaluate and repair/replace as needed.

Item 37 - Item- (Picture 1) Low water pressure

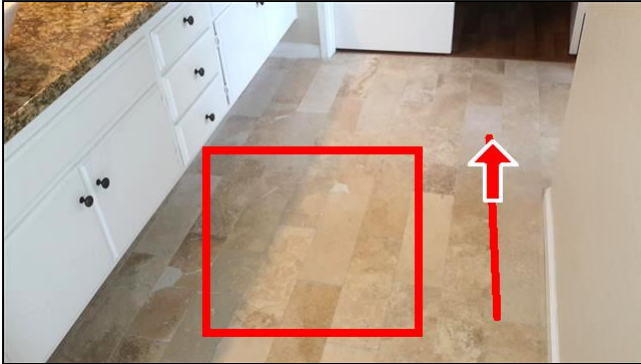
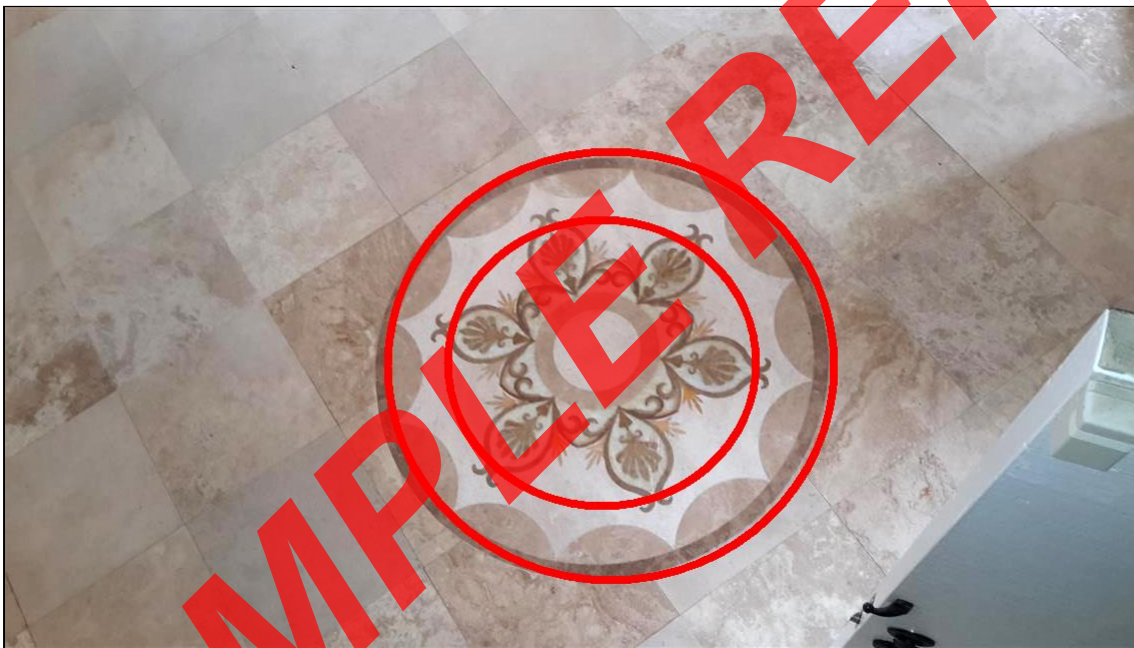
38. 1. Item- (Picture 1) The Master Bathroom floor tiles are loose and slants slightly.
2. Item- (Picture 2) The entry way circular tile is hollow in many areas. This affects the integrity of the tile if anything of some weight and hard falls on the tile. The tile may crack. This may be the area where the seller has disclosed that there was a foundation crack that had been repaired.
- **We recommend that a licensed contractor evaluate and repair/replace as needed.**

Item 38 - Item- (Picture 1) Loose tile and floor slats slightly

Item 38 - Item- (Picture 2) Center circular tile is hollow

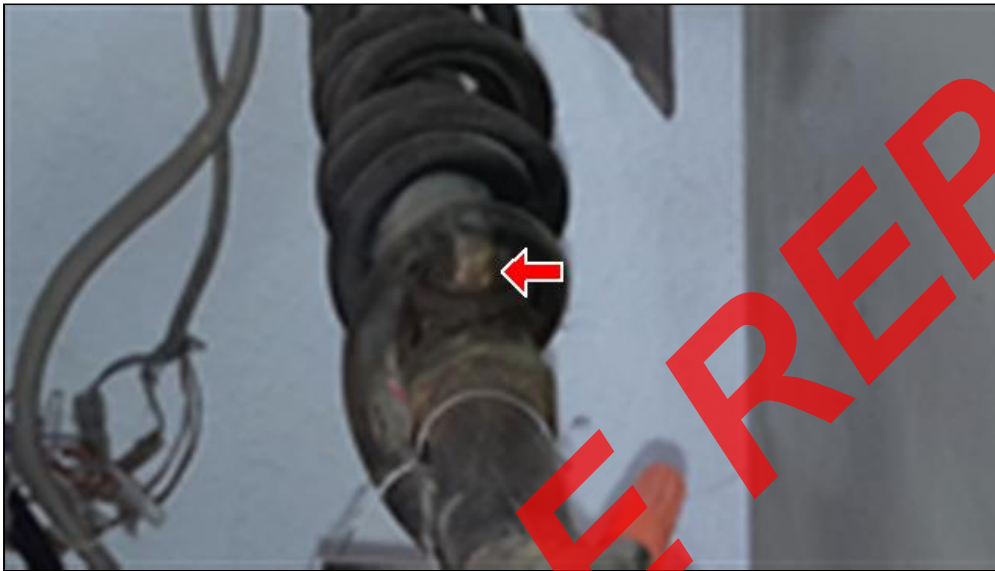
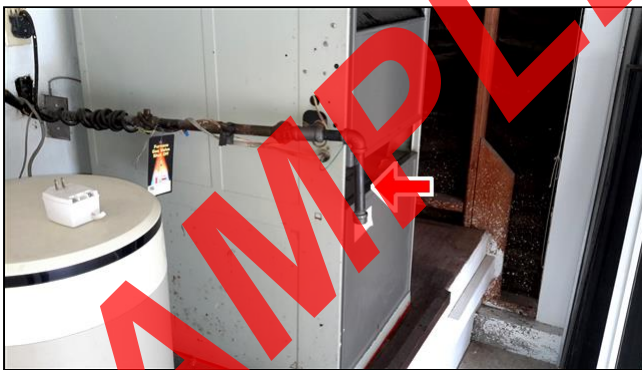
41. 1. Item- (Picture 1) The furnace gas shut-off valve is no longer acceptable as this type of valve requires a wrench to turn the valve. Current standards require a manual shut-off valve that can be turned by hand such as a Gas Ball Valve that can turn the gas off quickly without any special tools.
2. Item- (Picture 2) The gas sediment trap is designed to trap particles in the gas line that may damage the appliance it is attached to protect the appliance from premature damage. This installation does not trap the sediment before the gas reaches the appliance. This installation does not protect the furnace.
- **We recommend that a licensed plumbing contractor to evaluate and repair/replace as needed.**

Item 41 - Item- (Picture 1) Furnace Gas Shut-Off Valve is not a manual turn

Item 41 - Item- (Picture 2) Sediment trap not installed properly

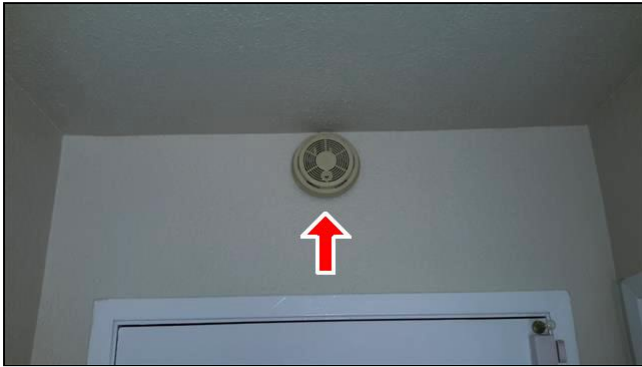
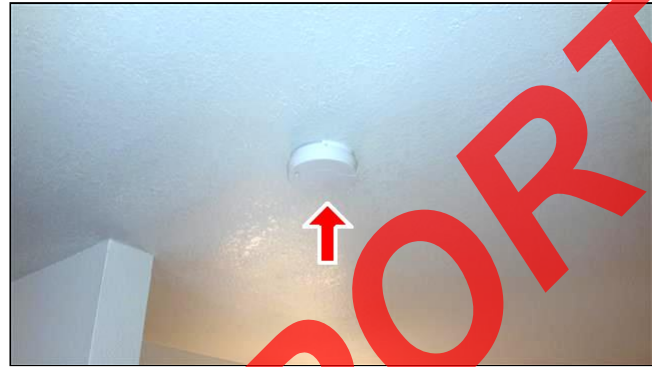
43. 1. Item- (Pictures 1 & 2) Bedroom 2, 3, & 4 smoke detectors are missing. Master bedroom smoke detector does not work. The downstairs smoke detector at the garage does not work. **This is a California State Law and a FIRE HEALTH SAFETY HAZARD which may cause personal injury and/or property damage.**
- We recommend that a licensed contractor evaluate and install as needed.

Item 43 - Item- (Picture 1) Does not operate when tested

Item 43 - Item- (Picture 2) Does not operate when tested

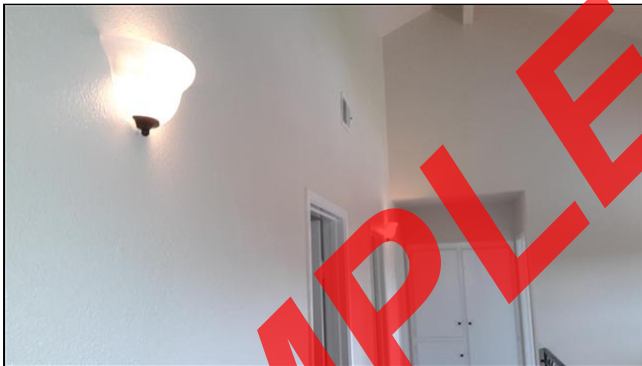
44. 1. There is no carbon monoxide detector installed upstairs. **This is a California State Law and a FIRE HEALTH SAFETY HAZARD which may cause personal injury and/or property damage.**
- We recommend that a licensed contractor evaluate and install as needed.

Item 44 - Item- (Picture 1) Hallway-No Carbon Monoxide Detector installed

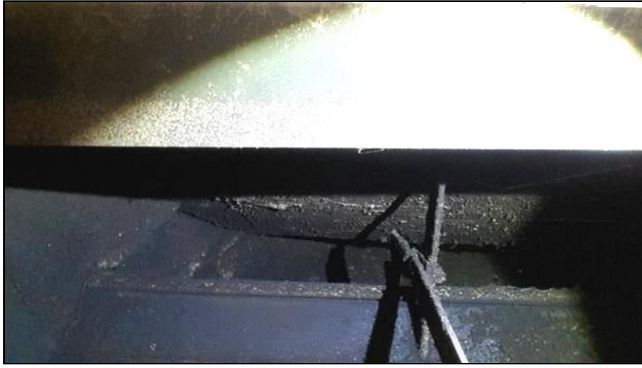
45. 1. There is excessive soot in the flue pipe/channel. Excessive soot may become combustible. Soot is caused from burning solid fuels such as wood. Natural gas burns clean.
- We recommend that a licensed chimney sweep contractor evaluate and clean as needed.

Item 45 - Item- (Picture 1) Excessive soot
