## Partial Sample Inspection Report

**Property Address:**  
123 Sample Street,  
San Diego, CA 9xxx

**All State Home Inspections, Inc.**

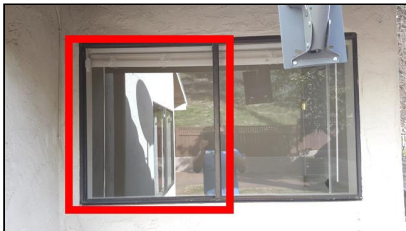
Item 7 - Item- (Picture 3) No window screens installed

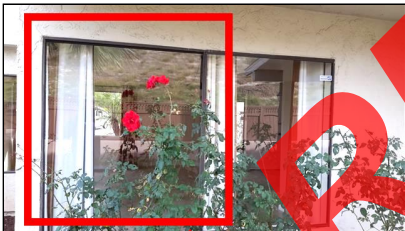
Item 7 - Item- (Picture 4) No window screens installed

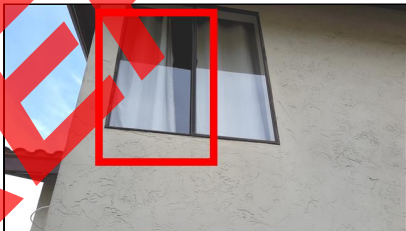
Item 7 - Item- (Picture 5) No window screens installed

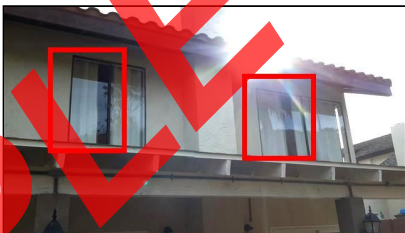
Item 7 - Item- (Picture 7) No window screens installed

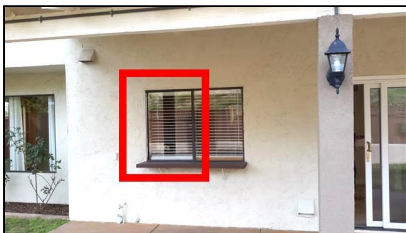
Item 7 - Item- (Picture 8) No window screens installed

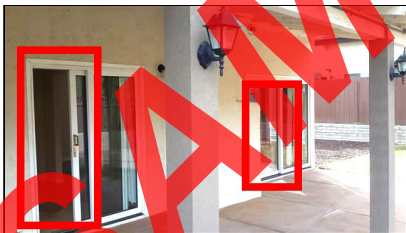
Item 7 - Item- (Picture 9) No window screens installed
